# Survey and excavations at Solomon's Pools, Palestine: 2018 preliminary report

Matthew J. Adams, Mark Letteney & Max T. B. Peers

This article provides an initial archaeological and historical overview of the Lower Pool at the Pools of Solomon south of Bethlehem, Palestine.

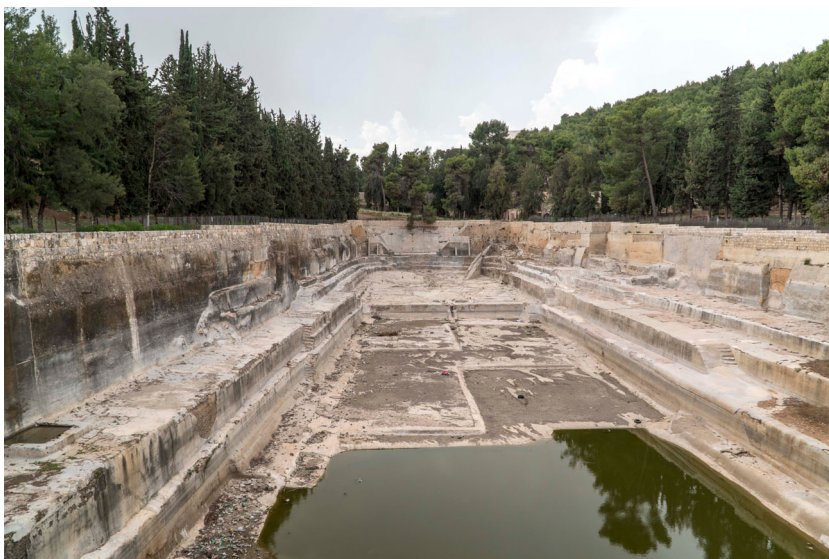
The LP was re-plastered numerous times over its history, and in some places as many as seven layers of plaster can be seen (more below). Currently much of the pool is coated with a grey concrete plaster laid in square patches with expansion joints between them

**Figure 5.** General photo of the Lower Pool from on top of the Dam Wall, looking west.

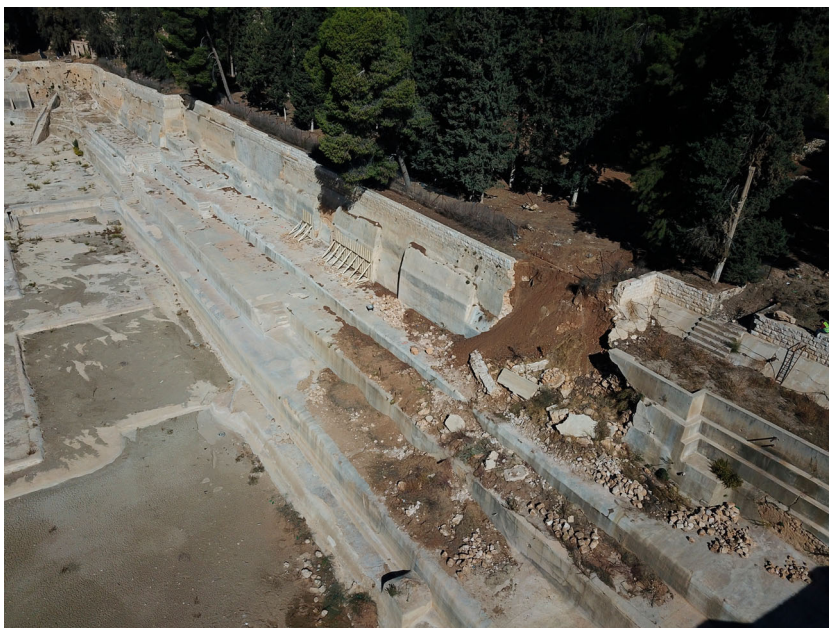
Additional data concerning the architectural history of the LP was accessible due to the recent collapse of a ca. nine-metre section of the northern wall (Figure 6). The collapse, and the construction and conservation work carried out to repair it, allowed for visual inspection of wall at that location that yielded a number of stratigraphic observations. Buckling of the upper portions of the south wall also provided an opportunity to record aspects of the constructional history of the pool at that location through a test trench abutting the exterior of the wall.<sup>4</sup> These opportunities to investigate the pool (along with other investigations of that dam wall, detailed separately below) have allowed for the establishment of a baseline stratigraphic framework that can be applied to the whole pool.

**Figure 6.** Photo of the collapsed portion of the North Wall of the Lower Pool.

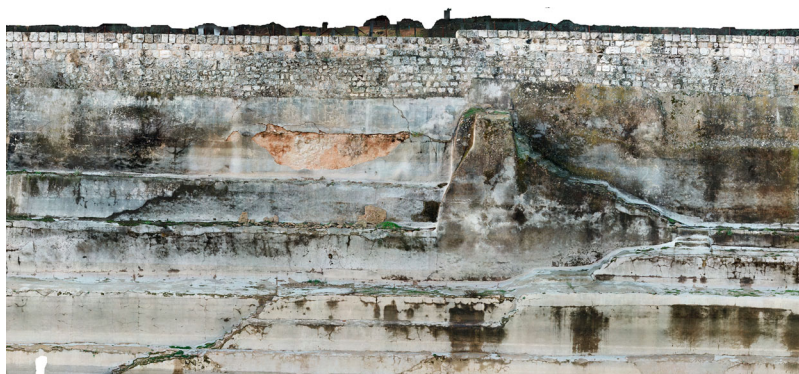
secured by mortar in at least two distinct phases (Figure 8). The interface of the bedrock and the built wall on top of it can be seen at the point where the buckling wall has caused plaster to fall from the seam (Figure 9). At this same level, immediately to the west of the buckling, a bedrock-hewn staircase within the pool reaches its height, apparently put out of commission by the construction of the built wall. The built wall that exists now, therefore, was not a part of the original construction of the pool.

**Figure 9.** Orthophoto of the Southern Wall of the Lower Pool, showing collapsed plaster due to the buckling of the wall above. Collapsed plaster reveals bedrock with upper retaining wall. Note bedrock staircase cut off at centre right. The upper two courses of wall are of relatively recent vintage (ca. Medieval-modern).

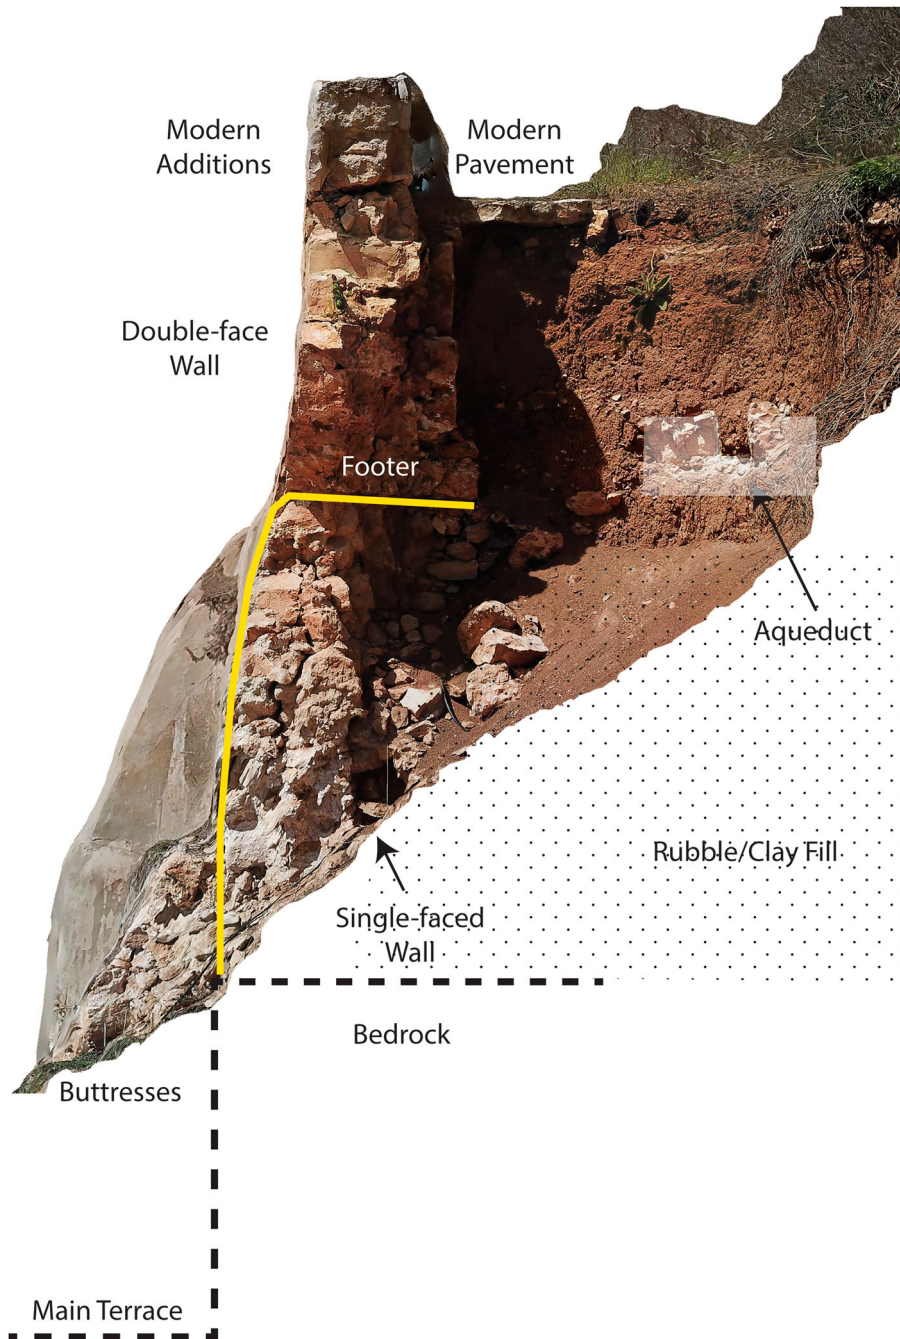
The north wall exhibits at least five different phases at the location of the recent wall collapse, including two renovations in the British Mandate period and one more recently (Figures 13 and 14). Along the wall the native bedrock is at its lowest point, meaning that the built wall on top of the bedrock is one of the tallest artificial walls in the pool. The

**Figure 13.** Strata in collapse of northern wall. At bottom, the 'single face wall' is the earliest discernable at this location, due to debris still covering the lowest portions. This single-face wall is of a revetment style, built up against a cut section of earth and meant to support it. The 'double-face wall' was designed as freestanding, and thus earth built up against the outside of it is stratigraphically later.

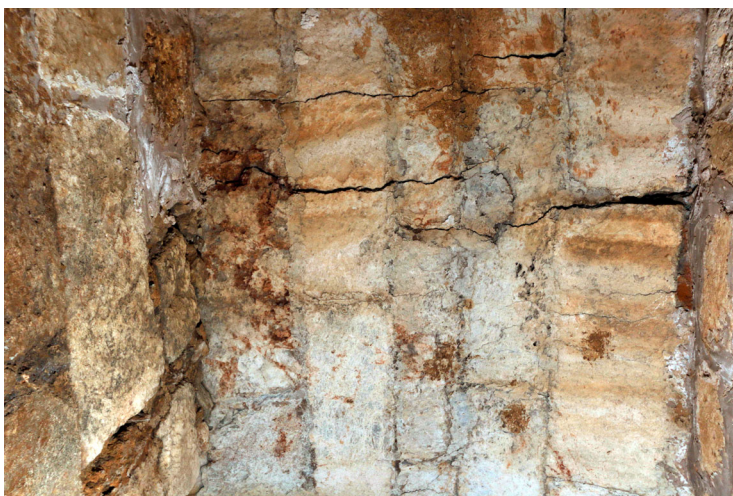
**Figure 21.** Photo of cracked ceiling within the interior chamber.

Significant damage to the Dam Wall can be seen within the interior structures, including the lateral movement of the staircase, the exterior wall at the entrance to the central chamber, and the cracking within the ceiling of the chamber. It is not clear if this damage happened over time or was the result of a single episode such as an earthquake. It is also unclear if the damage began a period of abandonment of the pool or if the pool was no longer in use when the damage occurred.

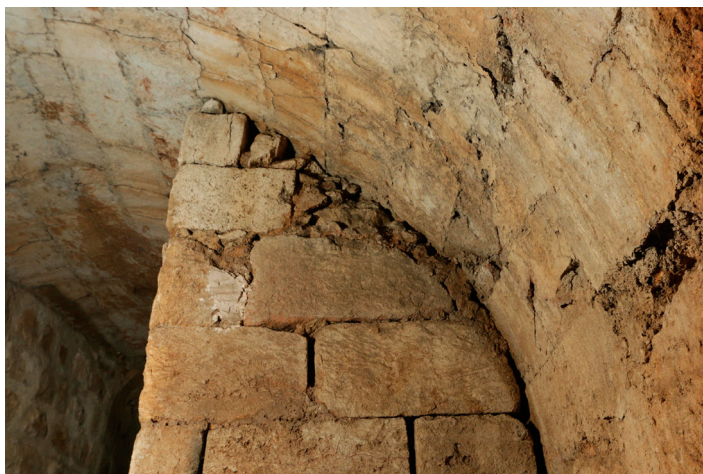
and the buttress has been constructed to prevent further collapse (Figure 24). Within the rectangular vaulted chamber two buttresses were added at the centre of the north and south walls to support the ceiling (Figure 22). Additional support was added to these buttresses in the last two decades.

**Figure 22.** Photo of the first buttress against the south wall of the original chamber.
