# Survey and excavations at Solomon's Pools, Palestine: 2018 preliminary report

Matthew J. Adams, Mark Letteney & Max T. B. Peers

This article provides an initial archaeological and historical overview of the Lower Pool at the Pools of Solomon south of Bethlehem, Palestine.

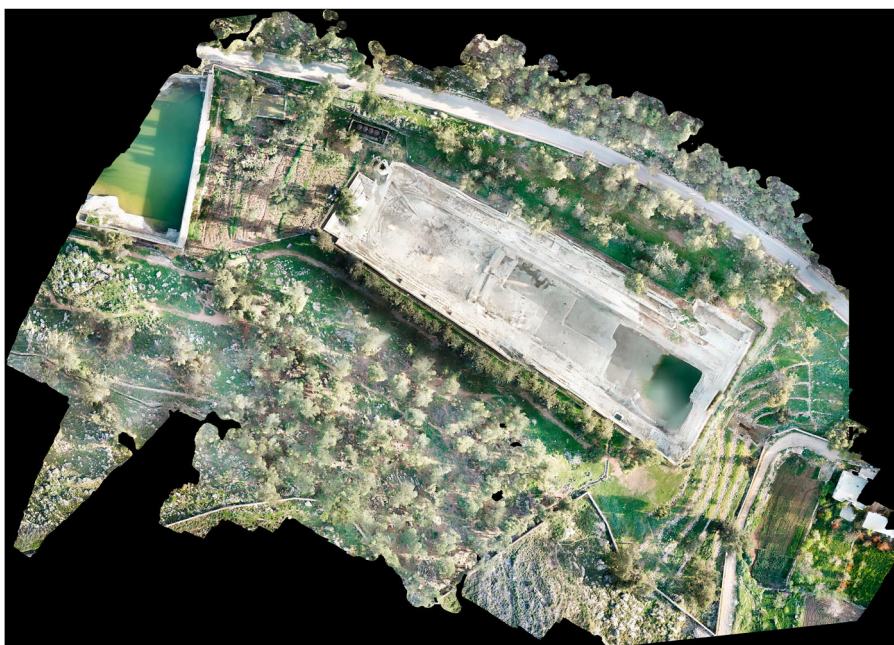
**Figure 4.** Orthophoto of the Lower Pool. North is up. Data collected 21 March 2018.

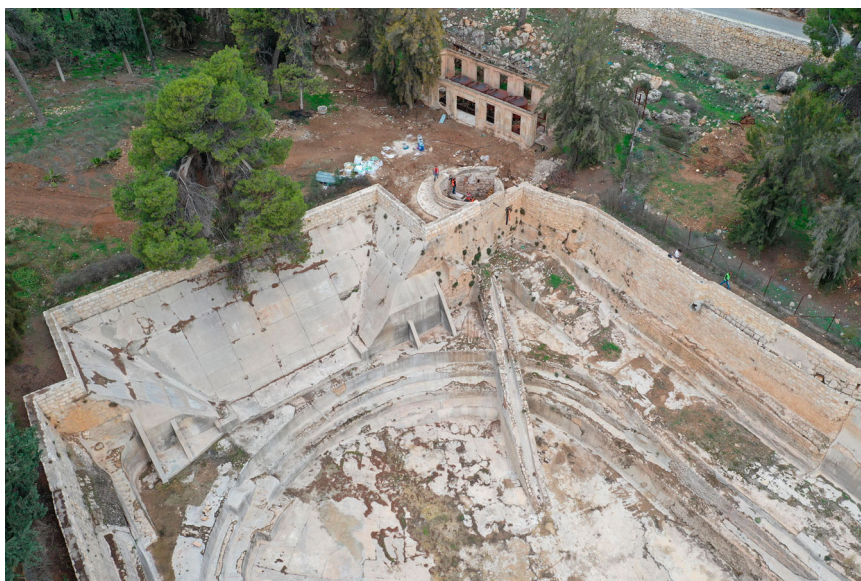
**Figure 7.** Photo of the northwest corner of the Lower Pool showing examples of the interior terraces of the pool. The large portion of the South Wall that is part of the British Mandate renovation. Note the sloping channel into the pool at centre.

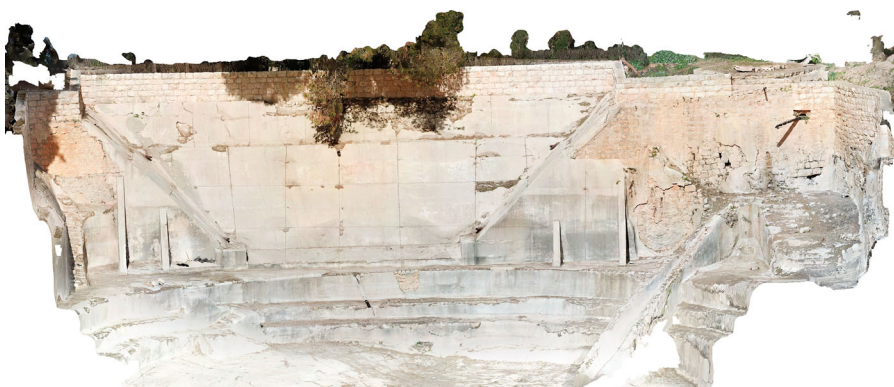
The majority of the western wall is covered by a poured concrete revetment with steel pipe inlets (Figure 10). A similar addition to the pool is in the northwest corner, also of poured concrete. These renovations took place in the years between 1923 and 1939, most likely in 1932 as a result of a breach in the wall caused by flash flooding (*Palestine Bulletin* 1932). These two renovations comprise the latest significant interventions in the LP, though smaller additions were made periodically since then (see below).

**Figure 10.** Orthophoto of the West Wall of the Lower Pool.

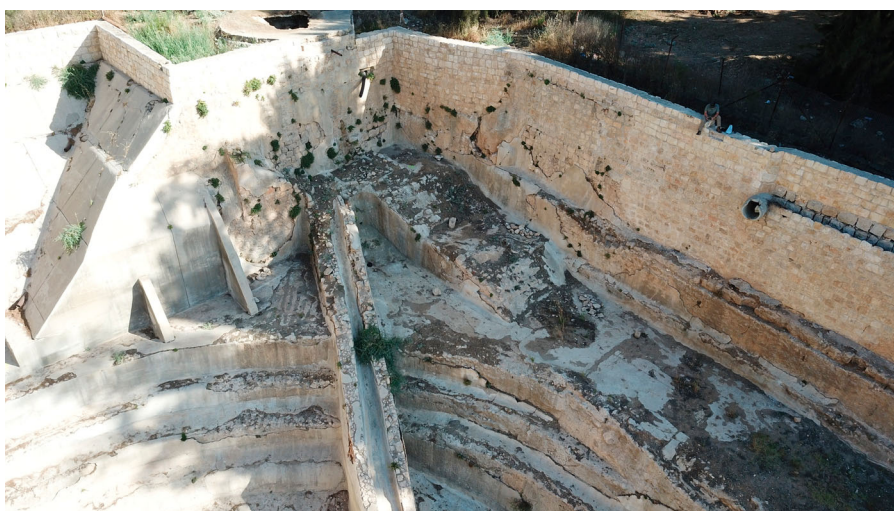
**Figure 11.** Photo of northwestern corner of the Lower Pool. Note the traces of two basins (filled with earth) at the top of the sloping channel and the wide staircase.

The native bedrock was not quarried out as deeply in the northwestern interior as it was in the remainder of the pool. An elevated platform at this point shows remains of two basins cut from the bedrock that seem to correspond to two inlet passages coming from the exterior tank (Figures 7 and 11). Immediately east of these basins is a wide staircase that descends to the 'Main Terrace' level within the pool. It is difficult to tell if the basins are original or if they have been cut out of this staircase, which may or may not have continued upwards to the west.

South of these basins is the broken remains of an aqueduct which sloped southwest from this point to the bottom of the pool (Figures 7 and 11). The aqueduct appears to be an original feature of the pool. While most of the channel is covered with plaster, an architectural section cut into the plaster showed that the bulk of the feature comprises bedrock with two courses of hewn stones placed on top to form the outer walls of the channel. The channel is built of stone with a lime mortar and plastered in at least two distinct phases. Remains of at least four layers of plaster around the base of the feature indicate repeated plastering, as well. The earliest plaster within the channel and at the base is a reddish colour, tinted by the inclusion of ceramic grog.

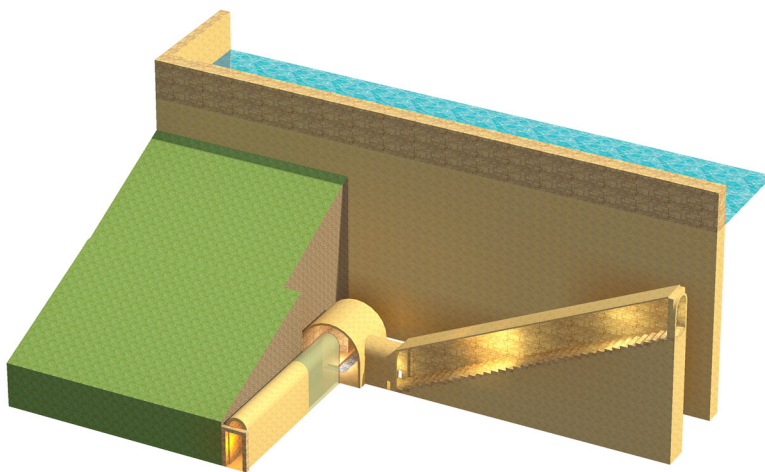
**Figure 18.** Schematic model of the Dam interior (model by Michael Horton).

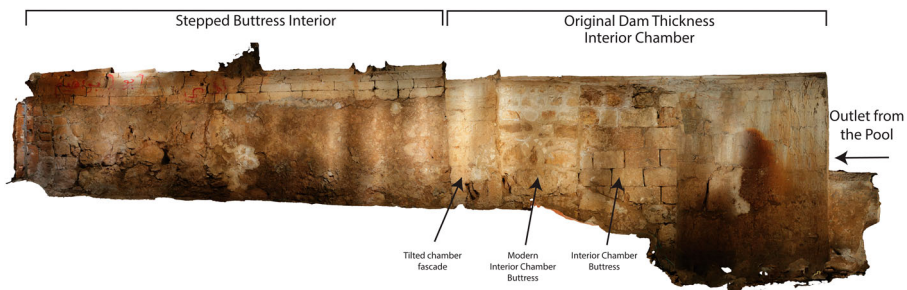
Approximately 10 metres into the dam one can see the seam between the original Dam Wall and the buttress, as well as evidence that the original Dam Wall became structurally compromised, necessitating the addition of the buttress (Figures 20–22). Serious cracks in the ceiling of the original vaulted chamber are present and the front wall of the vaulted chamber (which was part of the facade of the original Dam Wall) has buckled outward,

**Figure 20.** Orthophotographic section through the Dam passageway and interior chamber, facing south.
